# the **play** inspection company

## Annual Inspection

Sample Organisation

Sample Site

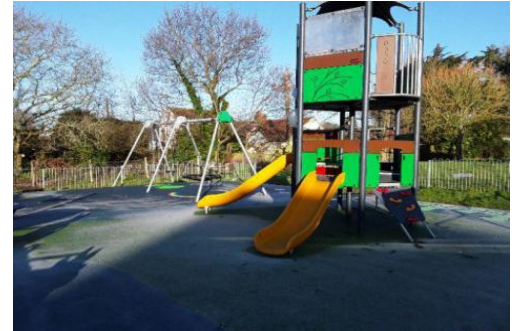
**Item:** Site General  
**Manufacturer:** Owner/Operator  
**Surface Type:** N/A  
**Item Quantity:** 1  
**Equipment Compliance:** N/A  
**Surface Area Compliance:** N/A

There is a self-made rope or tyre swing present. This type of construction is not recommended unless the trees / branches and connections have all been independently tested and checked by a competent person for sufficient structural stability, a suitable impact attenuating surface is provided on the seat itself and the surface underneath and a separately documented risk assessment and control measures are in place. - Remove

There is a large pile of logs and tree debris from a fallen tree - Remove

The fence adjacent to the play area is damaged - Replace

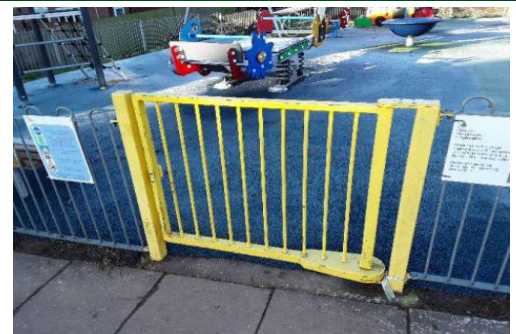
**Item:** Gate - Self Closing  
**Manufacturer:** I.A.E. Fencing  
**Surface Type:** Concrete  
**Item Quantity:** 1  
**Equipment Compliance:** N/A  
**Surface Area Compliance:** N/A

The paint is flaking off the metalwork - Rub down and re-paint

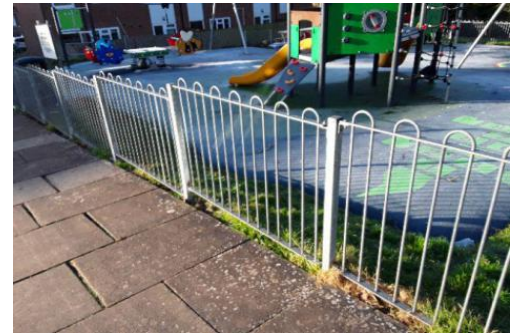
**Item:** Fence - Bow Top  
**Manufacturer:** Steelway/Fensecure  
**Surface Type:** Grass  
**Item Quantity:** 1  
**Equipment Compliance:** N/A  
**Surface Area Compliance:** N/A

There is some damage to the fence sections - Monitor for any further deterioration and repair as required

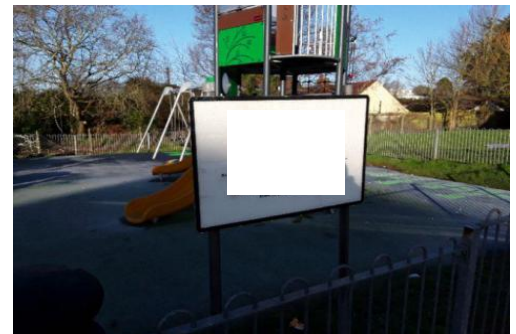
**Item:** Sign  
**Manufacturer:** Not Applicable  
**Surface Type:** Grass  
**Item Quantity:** 1  
**Equipment Compliance:** N/A  
**Surface Area Compliance:** N/A

There are post / end caps missing from the item - Replace missing post caps

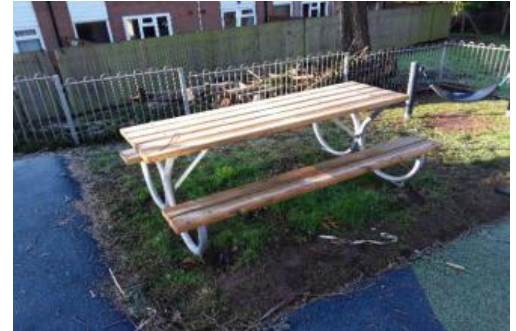
**Item:** Picnic Table  
**Manufacturer:** Kompan Ltd  
**Surface Type:** Grass  
**Item Quantity:** 1  
**Equipment Compliance:** N/A  
**Surface Area Compliance:** N/A

This item is satisfactory - no work required -

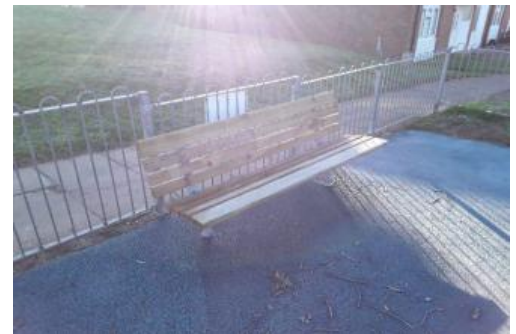
**Item:** Bench  
**Manufacturer:** Kompan Ltd  
**Surface Type:** Wet Pour  
**Item Quantity:** 1  
**Equipment Compliance:** N/A  
**Surface Area Compliance:** N/A

This item is satisfactory - no work required -

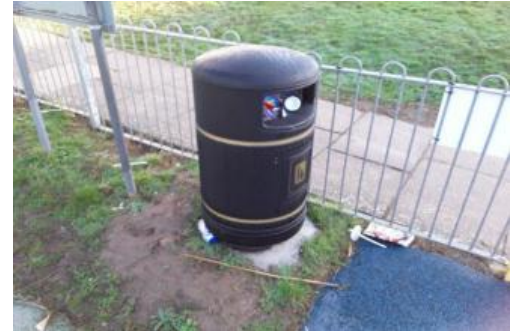
**Item:** Litter Bin  
**Manufacturer:** Glasdon  
**Surface Type:** Grass  
**Item Quantity:** 1  
**Equipment Compliance:** N/A  
**Surface Area Compliance:** N/A

This item is satisfactory - no work required -

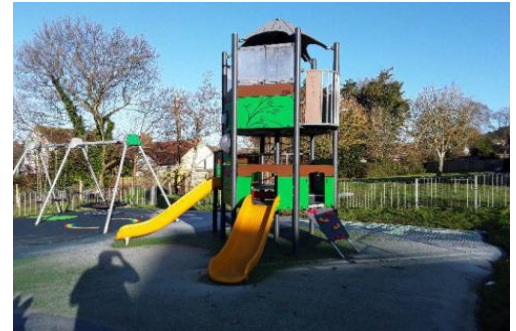
**Item:** Multi Play (Junior)  
**Manufacturer:** Kompan Ltd  
**Surface Type:** Wet Pour  
**Item Quantity:** 1  
**Equipment Compliance:** No  
**Surface Area Compliance:** Yes

There are falls in excess of 600mm between adjacent components on the structure, in contravention of the recommendations set out in BS EN 1176 Part 1; 4.2.8.4 - Monitor - No remedial work recommended

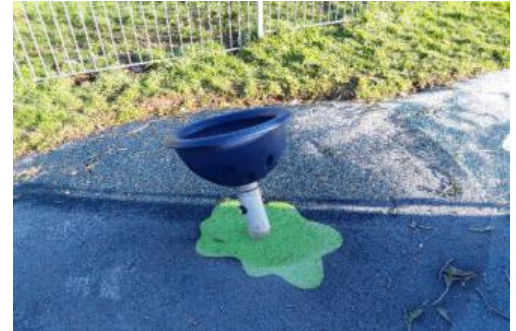
**Item:** Dish Roundabout  
**Manufacturer:** Kompan Ltd  
**Surface Type:** Wet Pour  
**Item Quantity:** 1  
**Equipment Compliance:** Yes  
**Surface Area Compliance:** Yes

This item is satisfactory - no work required -

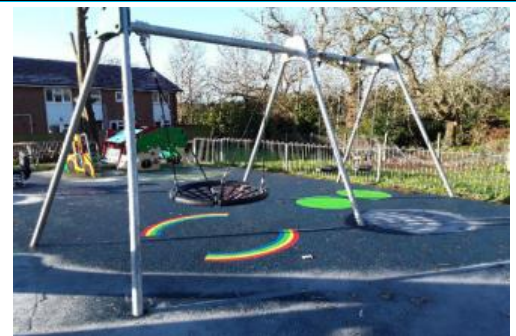
**Item:** 2 Bay 1 Flat 1 Basket  
**Manufacturer:** Kompan Ltd  
**Surface Type:** Wet Pour  
**Item Quantity:** 1  
**Equipment Compliance:** Yes  
**Surface Area Compliance:** Yes

This item is satisfactory - no work required -

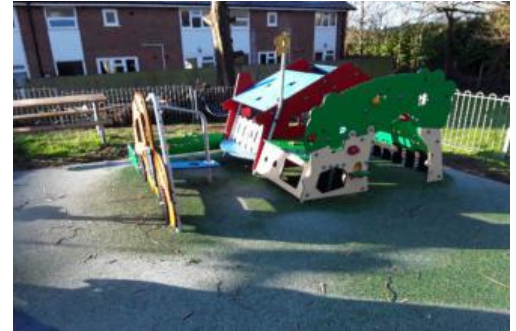
**Item:** Playhouse  
**Manufacturer:** Kompan Ltd  
**Surface Type:** Wet Pour  
**Item Quantity:** 1  
**Equipment Compliance:** Yes  
**Surface Area Compliance:** Yes

This item is satisfactory - no work required -

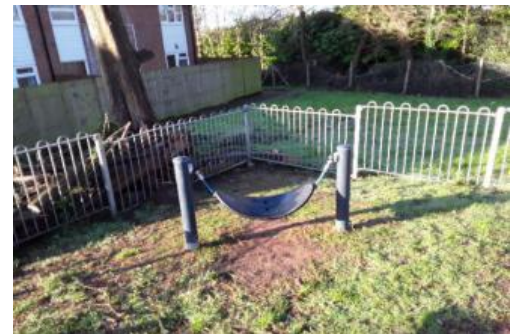
**Item:** Hammock  
**Manufacturer:** Kompan Ltd  
**Surface Type:** Grass  
**Item Quantity:** 1  
**Equipment Compliance:** Yes  
**Surface Area Compliance:** Yes

This item is satisfactory - no work required -

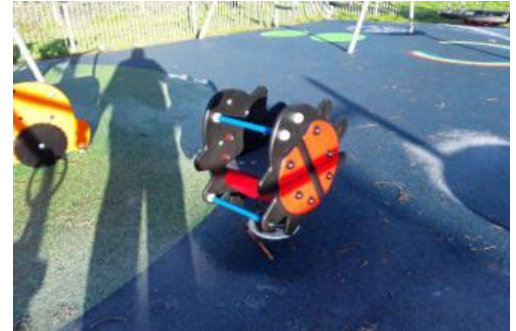
**Item:** Spring Ladybird  
**Manufacturer:** Kompan Ltd  
**Surface Type:** Wet Pour  
**Item Quantity:** 1  
**Equipment Compliance:** Yes  
**Surface Area Compliance:** Yes

This item is satisfactory - no work required -

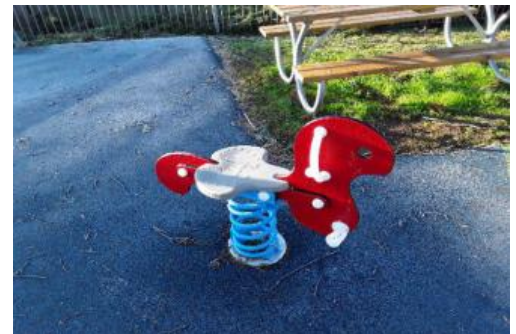
**Item:** Spring Dog  
**Manufacturer:** Kompan Ltd  
**Surface Type:** Wet Pour  
**Item Quantity:** 1  
**Equipment Compliance:** Yes  
**Surface Area Compliance:** Yes

This item is satisfactory - no work required -

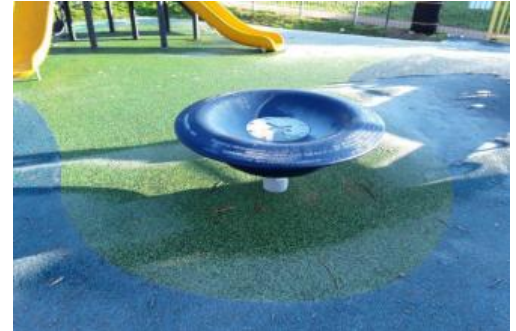
**Item:** Spinner Bowl  
**Manufacturer:** Kompan Ltd  
**Surface Type:** Wet Pour  
**Item Quantity:** 1  
**Equipment Compliance:** Yes  
**Surface Area Compliance:** Yes

This item is satisfactory - no work required -

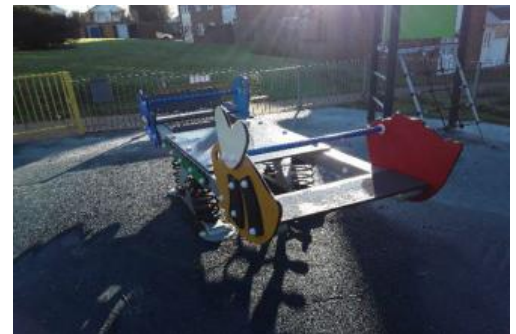
**Item:** Spring See-Saw  
**Manufacturer:** Kompan Ltd  
**Surface Type:** Wet Pour  
**Item Quantity:** 1  
**Equipment Compliance:** Yes  
**Surface Area Compliance:** Yes

This item is satisfactory - no work required -

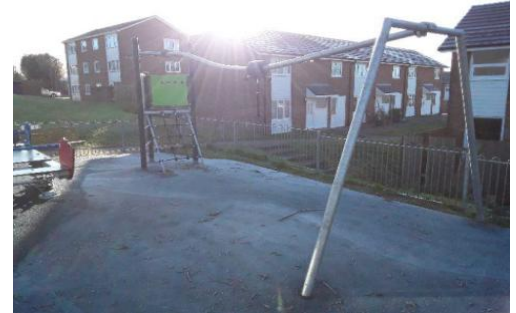
**Item:** Overhead Glider  
**Manufacturer:** Kompan Ltd  
**Surface Type:** Wet Pour  
**Item Quantity:** 1  
**Equipment Compliance:** No  
**Surface Area Compliance:** Yes

The height of the guardrail exceeds the maximum 850mm required by BS EN 1176 Part 1. We note however, that this is an intentional design feature to allow easier access onto the overhead glide and is supported by a Kompan design risk assessment - Refer to manufacturer design risk assessment

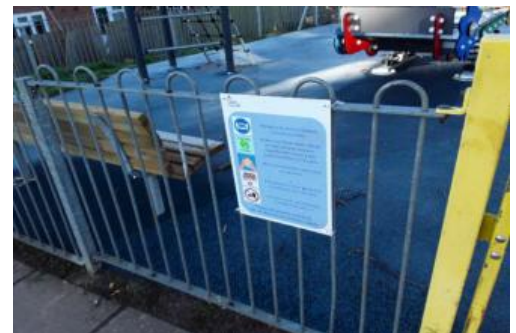
**Item:** Sign  
**Manufacturer:** Owner/Operator  
**Surface Type:** N/A  
**Item Quantity:** 1  
**Equipment Compliance:** N/A  
**Surface Area Compliance:** N/A

This item is satisfactory - no work required -

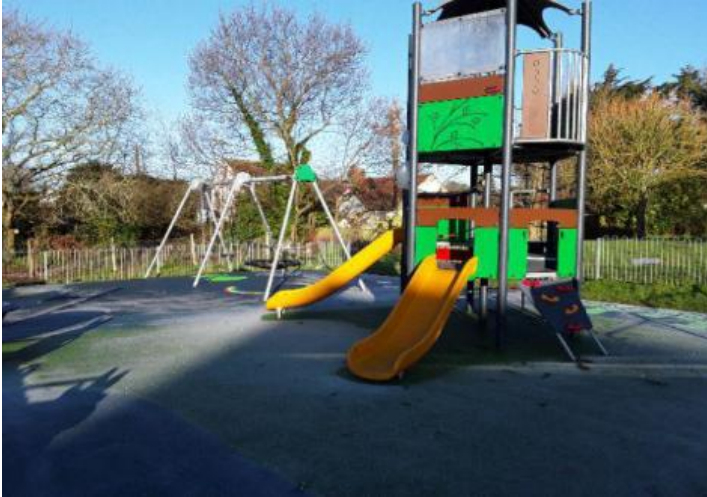
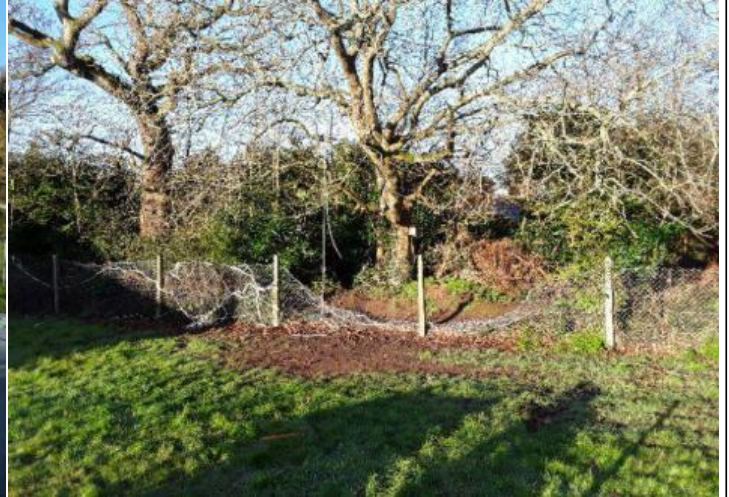
### 12 - Moderate Risk (Finding 1)

**Finding:** There is a self-made rope or tyre swing present. This type of construction is not recommended unless the trees / branches and connections have all been independently tested and checked by a competent person for sufficient structural stability, a suitable impact attenuating surface is provided on the seat itself and the surface underneath and a separately documented risk assessment and control measures are in place.

**Action:** Remove

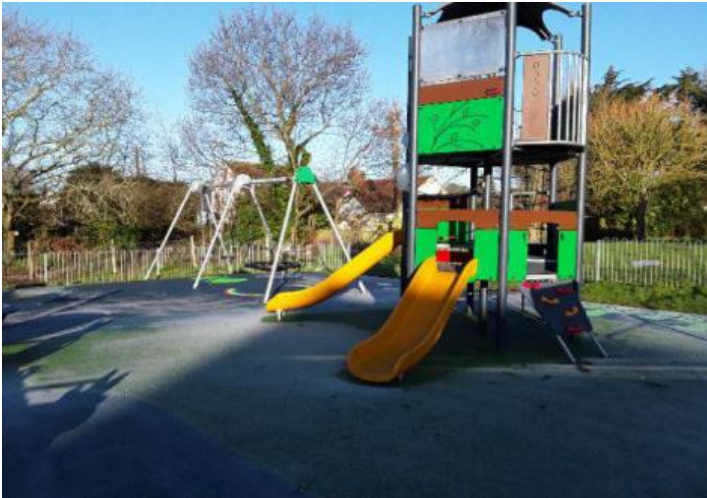
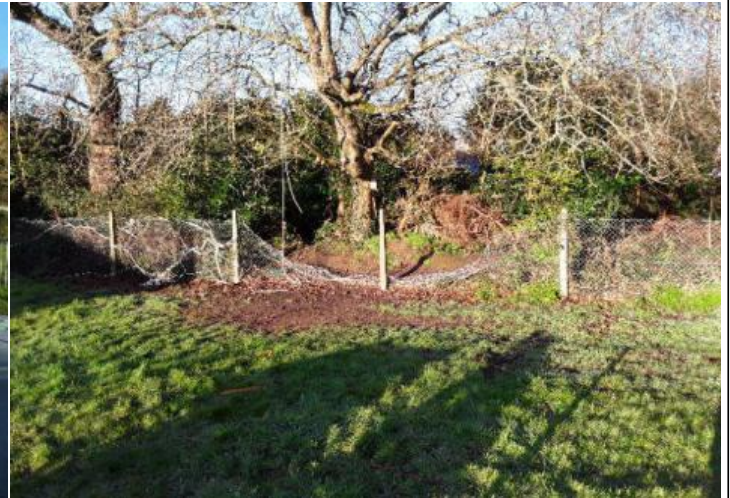
**i** 8 - Low Risk (Finding 2)

**Finding:** The fence adjacent to the play area is damaged

**Action:** Replace

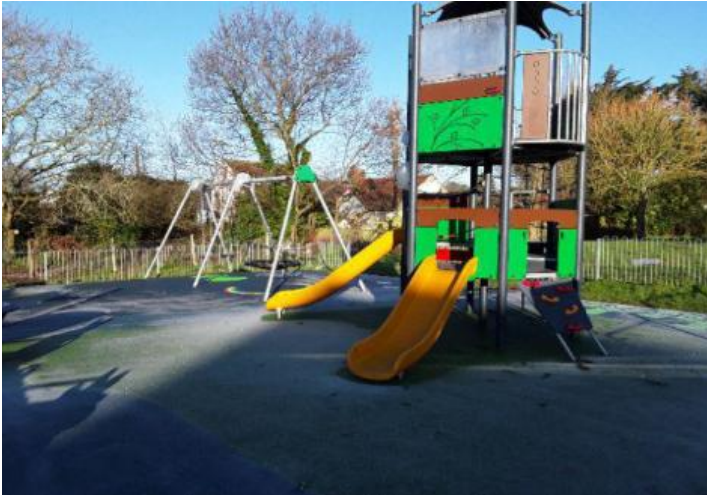
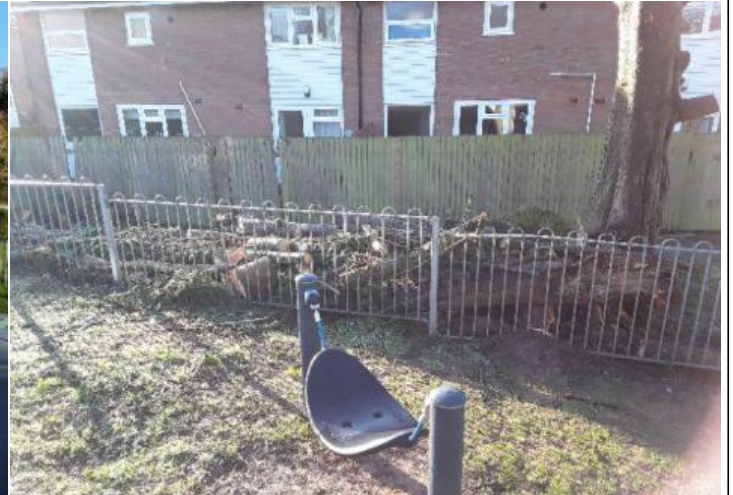
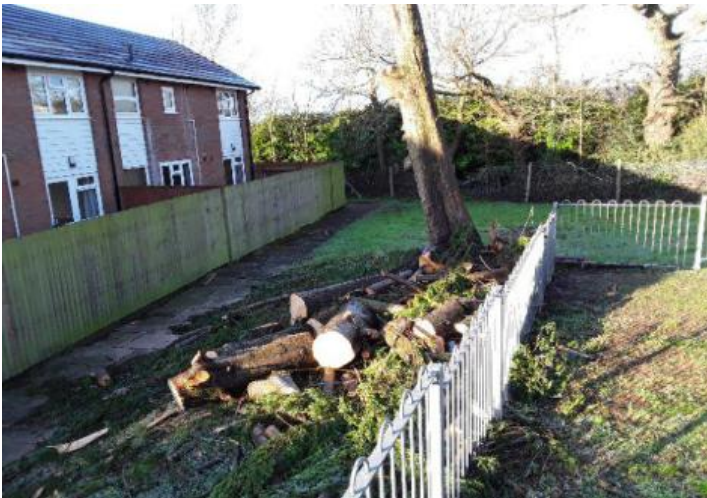
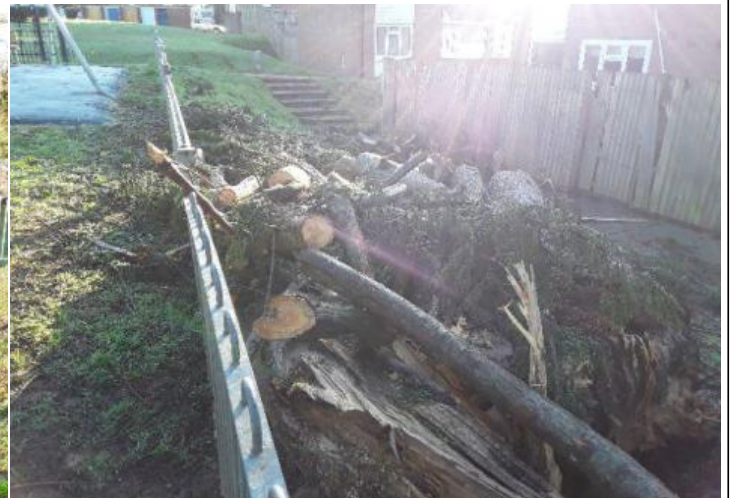
**!** 12 - Moderate Risk (Finding 3)

**Finding:** There is a large pile of logs and tree debris from a fallen tree  
**Action:** Remove

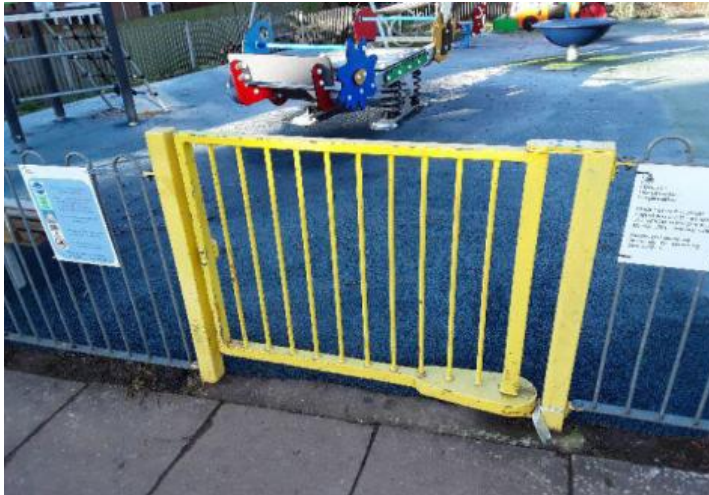
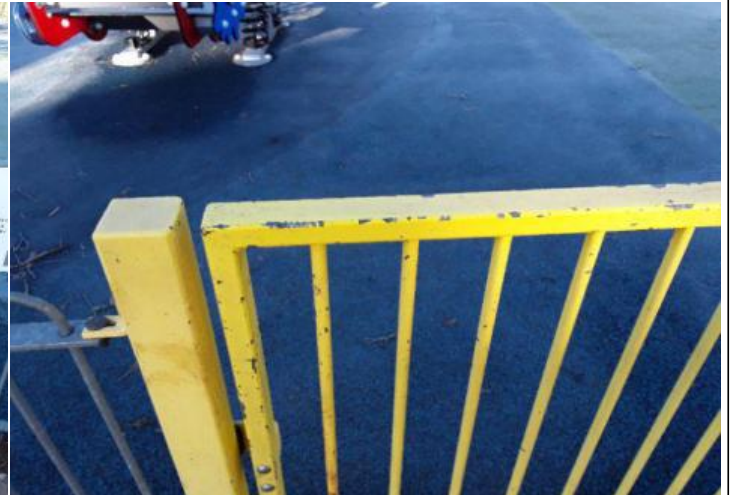
**i** 6 - Low Risk (Finding 1)

**Finding:** The paint is flaking off the metalwork

**Action:** Rub down and re-paint

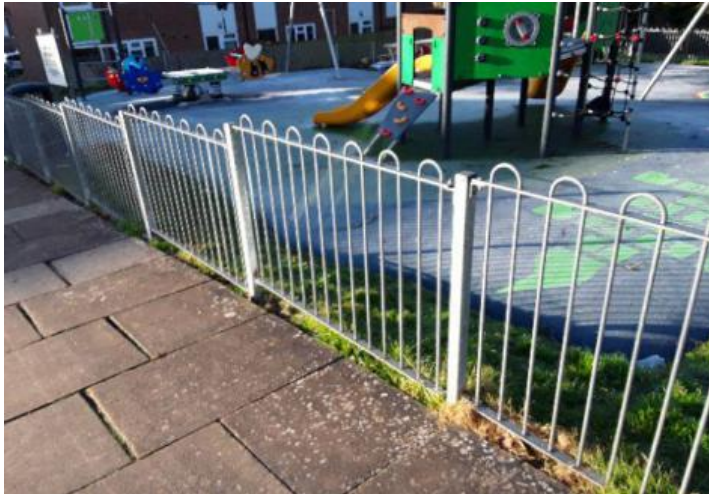
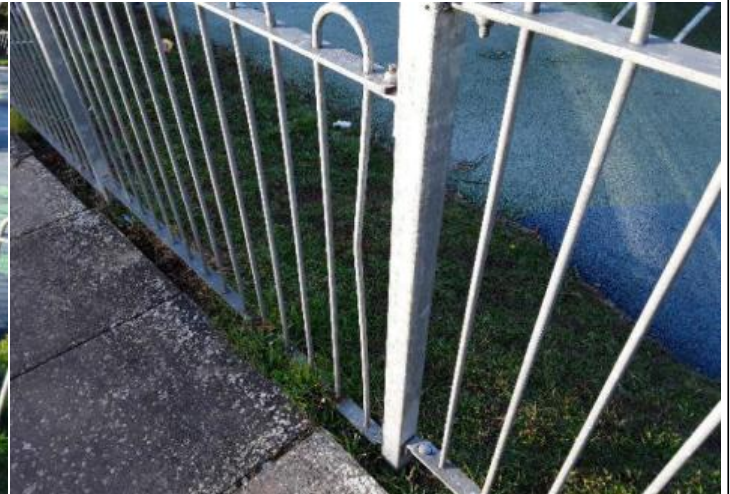
**i** 6 - Low Risk (Finding 1)

**Finding:** There is some damage to the fence sections

**Action:** Monitor for any further deterioration and repair as required

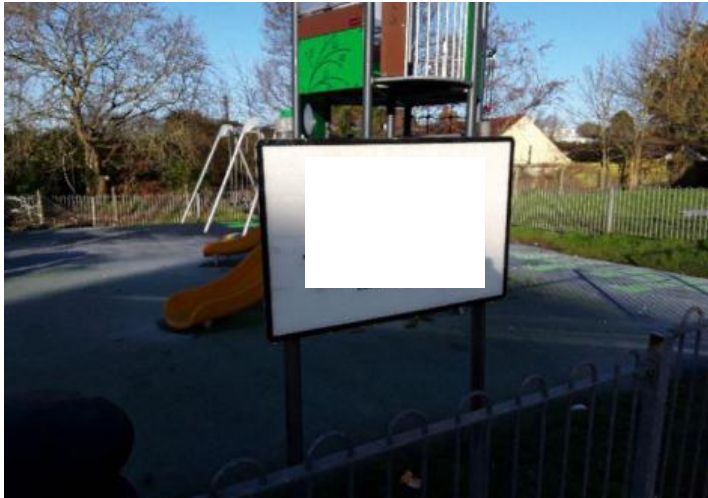
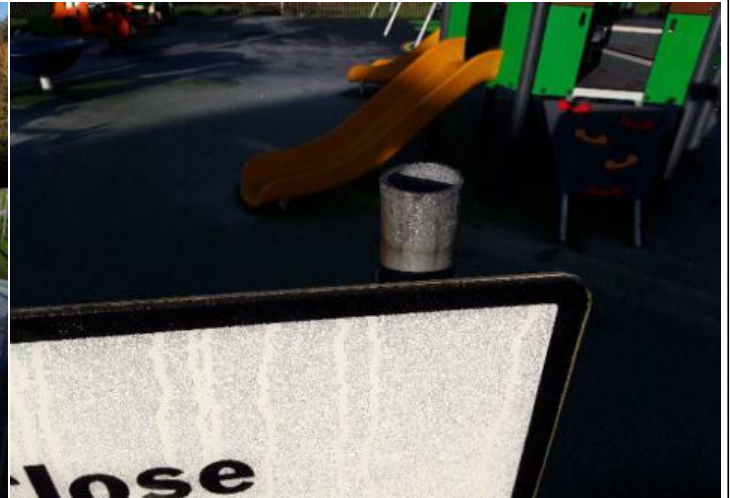
**i** 6 - Low Risk (Finding 1)

**Finding:** There are post / end caps missing from the item

**Action:** Replace missing post caps

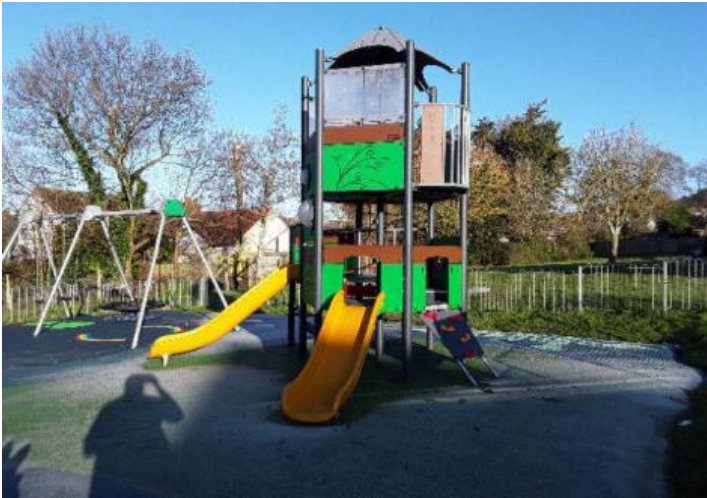
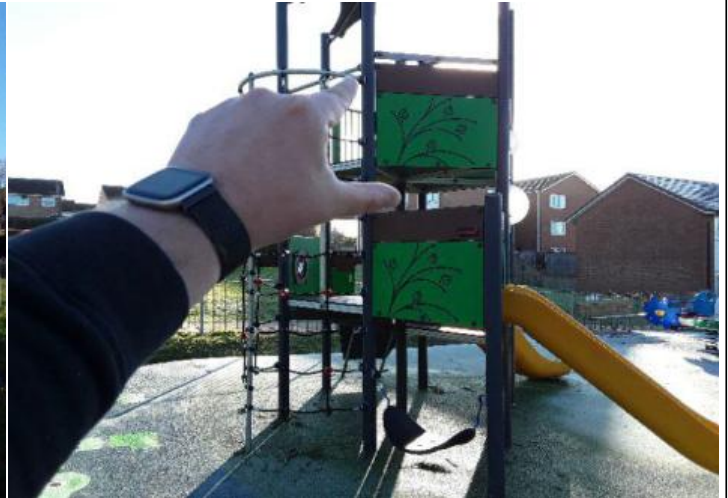
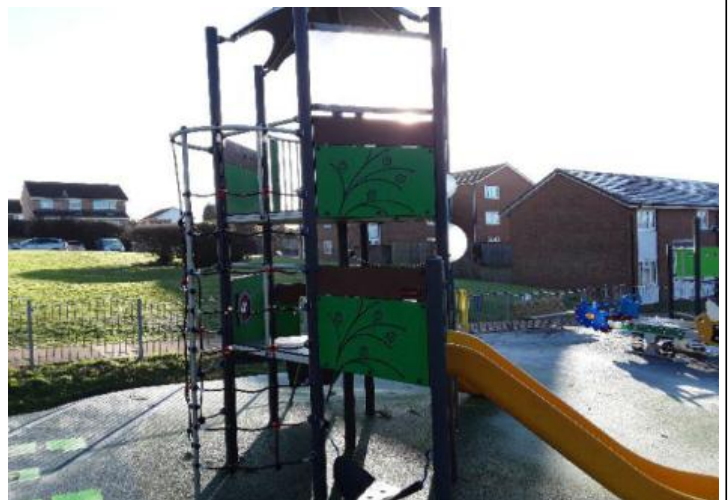
**i** 8 - Low Risk (Finding 1)

**Finding:** There are falls in excess of 600mm between adjacent components on the structure, in contravention of the recommendations set out in BS EN 1176 Part 1; 4.2.8.4

**Action:** Monitor - No remedial work recommended

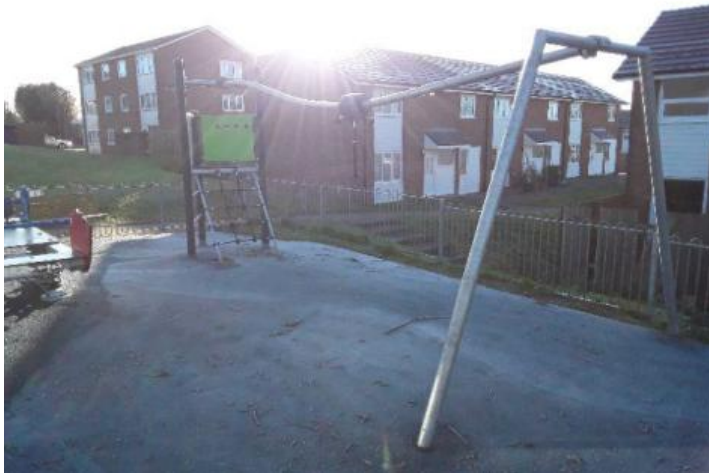
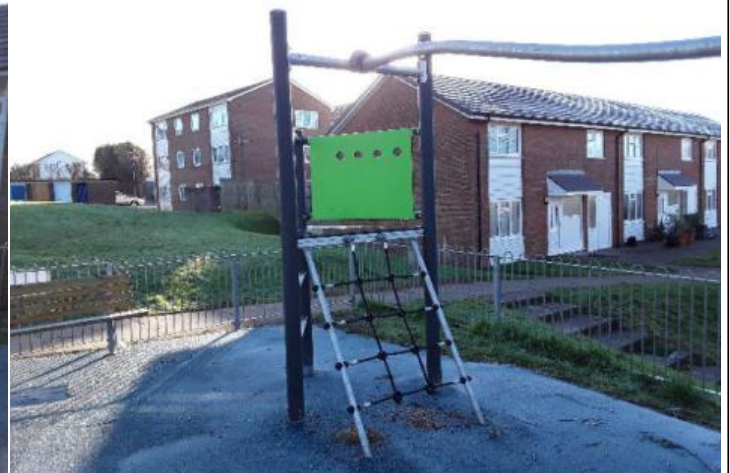
**i** 8 - Low Risk (Finding 1)

**Finding:** The height of the guardrail exceeds the maximum 850mm required by BS EN 1176 Part 1. We note however, that this is an intentional design feature to allow easier access onto the overhead glide and is supported by a Kompan design risk assessment

**Action:** Refer to manufacturer design risk assessment
