# Chandler Roofing.

## Roof inspection report.

### Property: Ellendune Community Centre Wroughton.

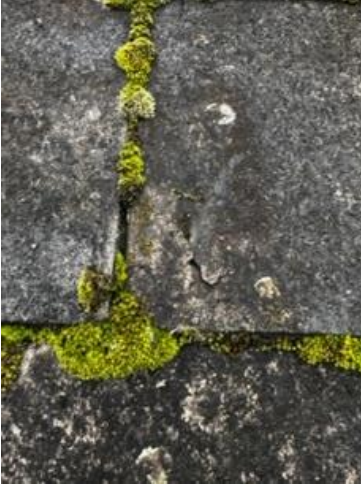
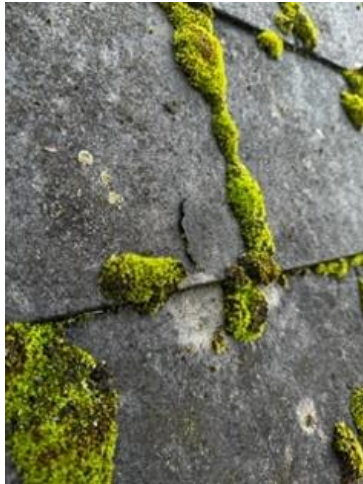
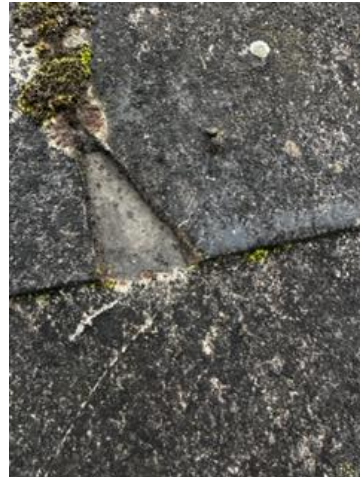
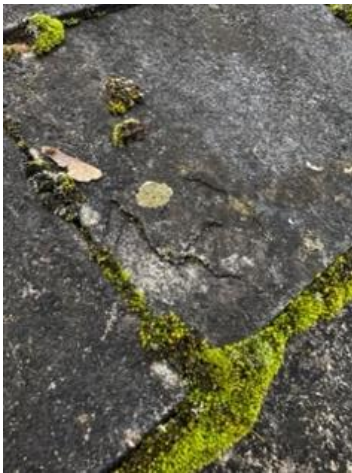
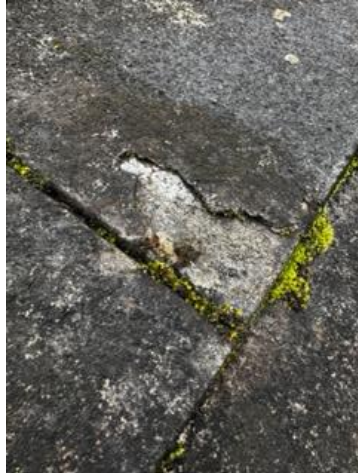
The slates are very old and are starting to show signs that indicate that they are presumably coming to the end of their life such as the faces being very worn and areas of the slates flaking away.

South west facing warn out slates

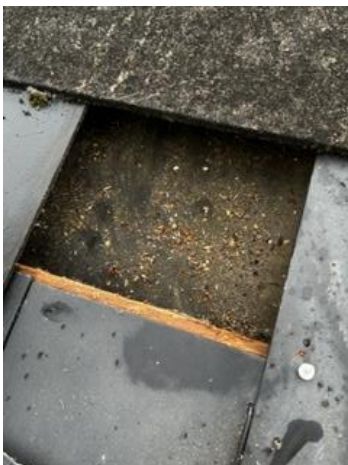
On inspection we were limited on areas we could view the felt, but we removed a slate and could see that the felt although, the old style and a non-breathable felt it still looked in a healthy condition.

south west facing felt condition

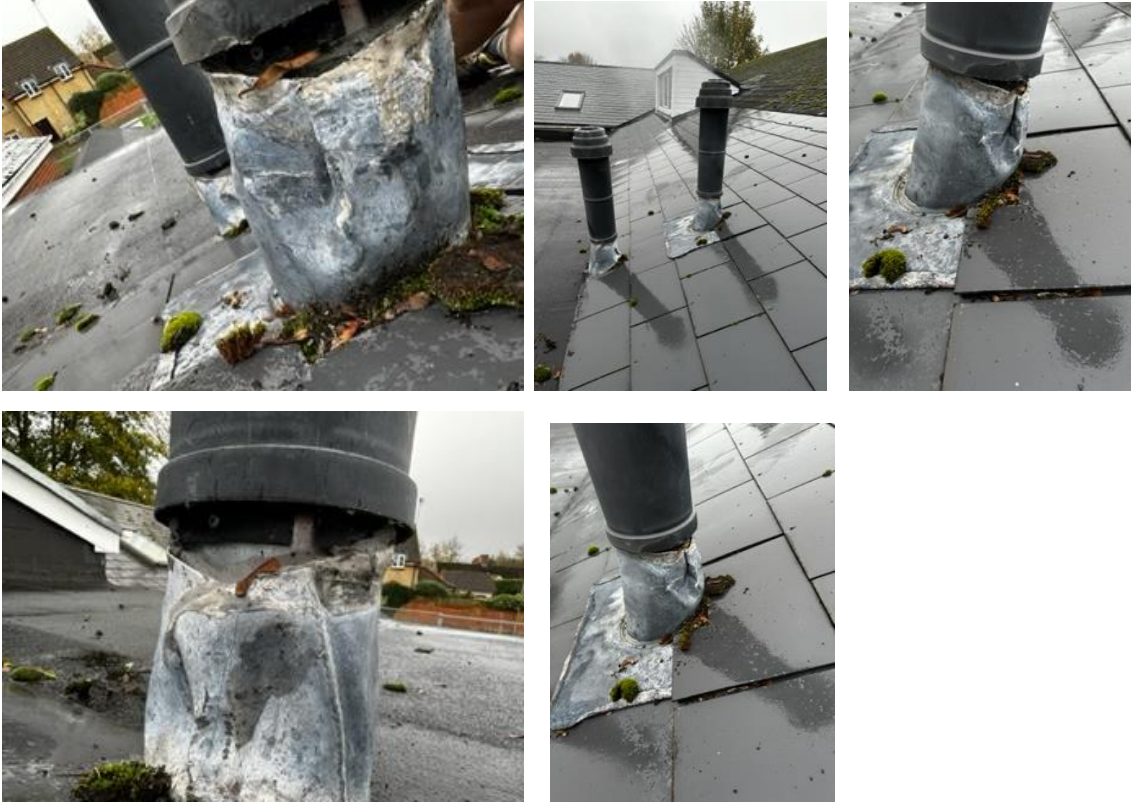
The lead slates around the flue pipes have both been made too large for the pipe and been dressed around on themselves in attempt to achieve a tighter fit, by doing this it puts areas of the lead at stress and can cause the lead to split. They have also failed to install the lead under the collar of the flue pipe leaving the area very prone to water ingress.

South west facing lead slate

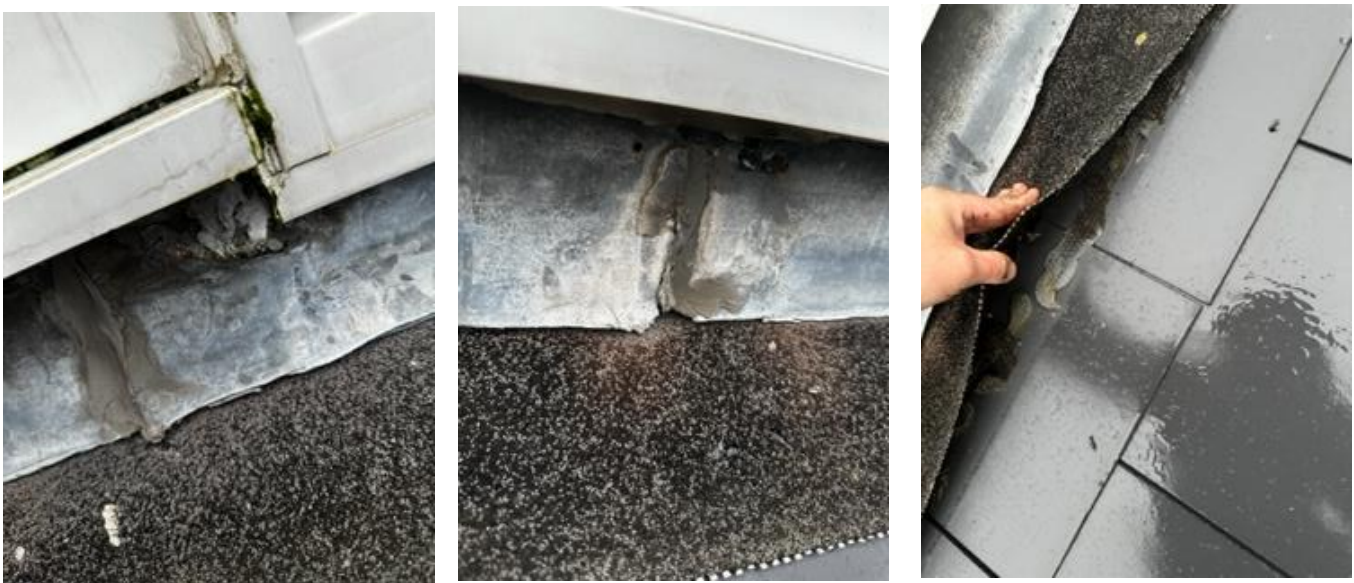
The lead flashing along the bay window has a few splits and could do with being replaced. It has also been cut down and repaired with bitumen strip tucked under the lead this will affect the integrity of the lead.

South west facing dormer lead

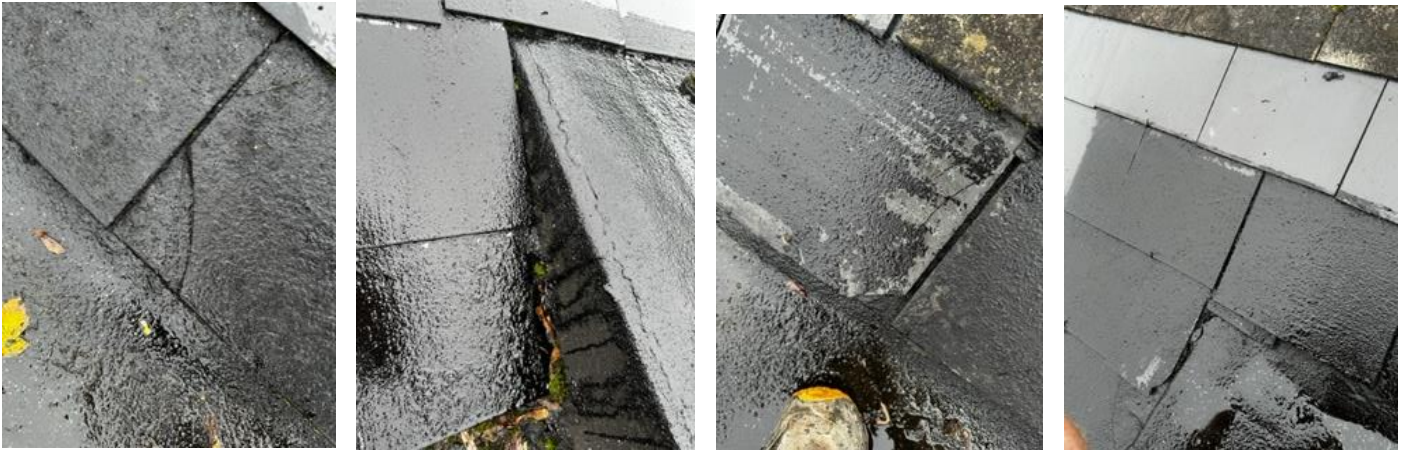
The Slates above dormer window coated in a bitumen paint again this indicates a quick fix over a possible leak.

South west facing slates coated in bitumen

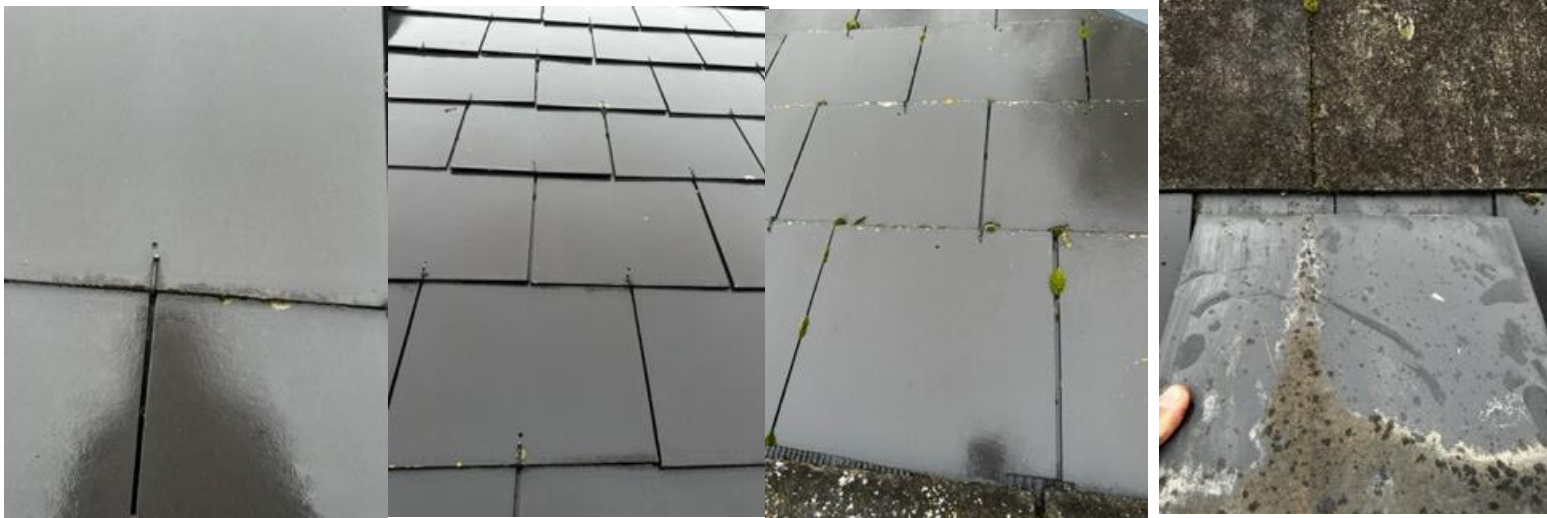
These slates should be installed half bounded to the slate directly below. This is to give the maximum possible coverage to protect from water ingress, unfortunately the contractor has failed to do this when installing the roof elevation.

The method to fix the slates in place on this elevation the previous contractor opted to use slate hooks. This method of fixing slates is very good for natural slates as they protect against wind up lift. But unfortunately, not necessary the best fixing for fibre cement slates as they are made from a much softer and less durable material, this means they may be prone to bending and losing shape due to the insufficient support. Manufacture instructions specify that slates should be secured by double nailing and with a copper rivet to the bottom centre of the slate.

south east facing incorrect fixings and out of bond slates

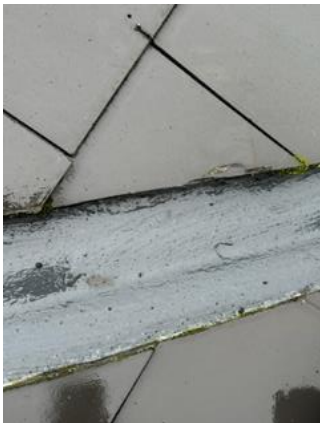
When the works were completed the previous contractor fitted a fibre glass valley trough this is common in more previous roof installations. For some reason it appears to have been coated in some sort of fibre paint, these types of products are very unreliable and should only be used as a temporary fix. By the valley being coated with this paint usually give the indication that there is an issue that should be addressed.

valley coated in fibre paint.

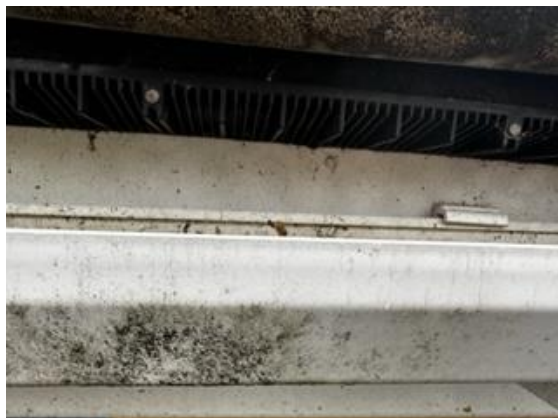
The over fascia vent is designed to allow air flow from the eave into the loft space to help prevent condensation issues. The over fascia vent is to be fitted on top of the fascia. In this case it has been fitted to the side of the fascia this will affect the performance of the product.

Incorrect fascia vent
