| <b>JOB #</b> | 835 |
| <b>CLIENT</b> | Ellendune Community Centre |
| <b>SITE ADDRESS</b> | Barrett Way, Wroughton, Swindon, SN4 9LW |

| ISSUE REPORTED | WORK CARRIED OUT |

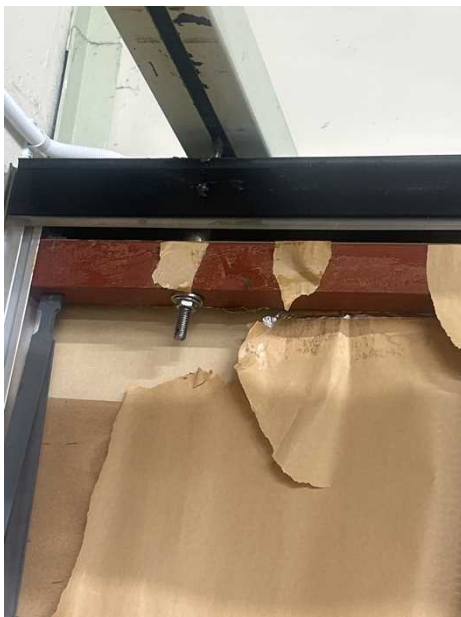
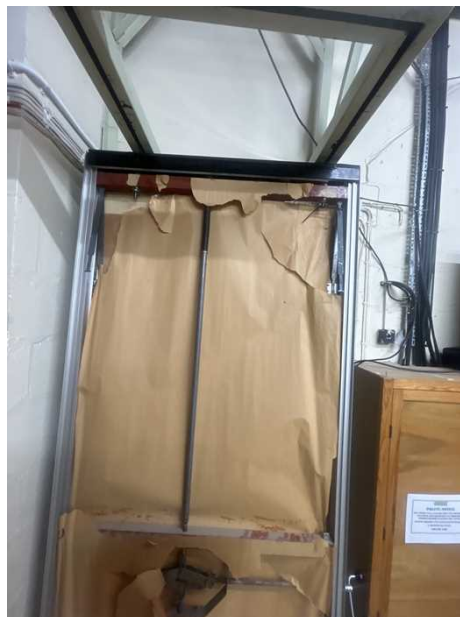
### BEFORE PHOTOS

| ISSUE REPORTED | WORK CARRIED OUT |
|---|---|
| General service and movable wall repairs | <p><b>Description of Works Completed</b></p> <p>Upon attendance, our engineers carried out a full inspection and repair of the movable wall system. The wall was stripped down in situ to access the internal roller housing components.</p> <p>During inspection, it was identified that the top roller housing bearing had insufficient fixings, which was causing instability in the operation of the wall panels.</p> <p>The faulty roller housing was secured with additional fixings, ensuring the section is now safe and operating correctly. Functionality tests were carried out following the repair, and the panel is now in safe working order.</p> <p style="text-align: center;">□</p> <p><b>Findings</b></p> <p>Further inspection revealed that several other panels are affected by the same issue, where the roller housings have inadequate fixings. This is considered a design flaw, which can compromise the structural integrity and stability of the movable wall system if not addressed.</p> <p style="text-align: center;">□</p> <p><b>Recommendations</b></p> <p>We strongly recommend that the same repair procedure—installing additional fixings to secure the roller housings—is carried out on the remaining affected panels as soon as possible.</p> |

| | Completing these additional repairs will: <ul style="list-style-type: none"> <li>• Prevent further structural degradation of the wall system</li> <li>• Ensure smooth and safe operation of all panels</li> <li>• Maintain compliance with safety and operational standards</li> </ul> <div style="text-align: center;"> <input type="checkbox"/> <br/> Status </div> <div> <input type="checkbox"/> Current panel: Repaired and operational<br/> <input type="checkbox"/> Remaining panels: Require further repair work </div> |
